National Transportation Safety Board

Marine Accident Brief

Collision between US Fishing Vessel *American Dynasty* and Canadian Naval Frigate *Winnipeg*

Accident no.	DCA13RM018
Vessel names	US fishing vessel <i>American Dynasty</i> ; Canadian Navy frigate <i>Winnipeg</i>
Accident type	Collision
Location	Esquimalt, British Columbia, Canada 48°25.9'N, 123°25.8'W
Date	April 23, 2013
Time	0817 Pacific daylight time (coordinated universal time – 7 hours)
Injuries	Six minor injuries
Damage	More than \$500,000 in damage to the vessels and pier
Environmental damage	None
Weather	Clear; good visibility; northeast winds at 3 knots
Waterway information	Protected harbor and entrance to graving dock; ebbing tide 3.6 feet

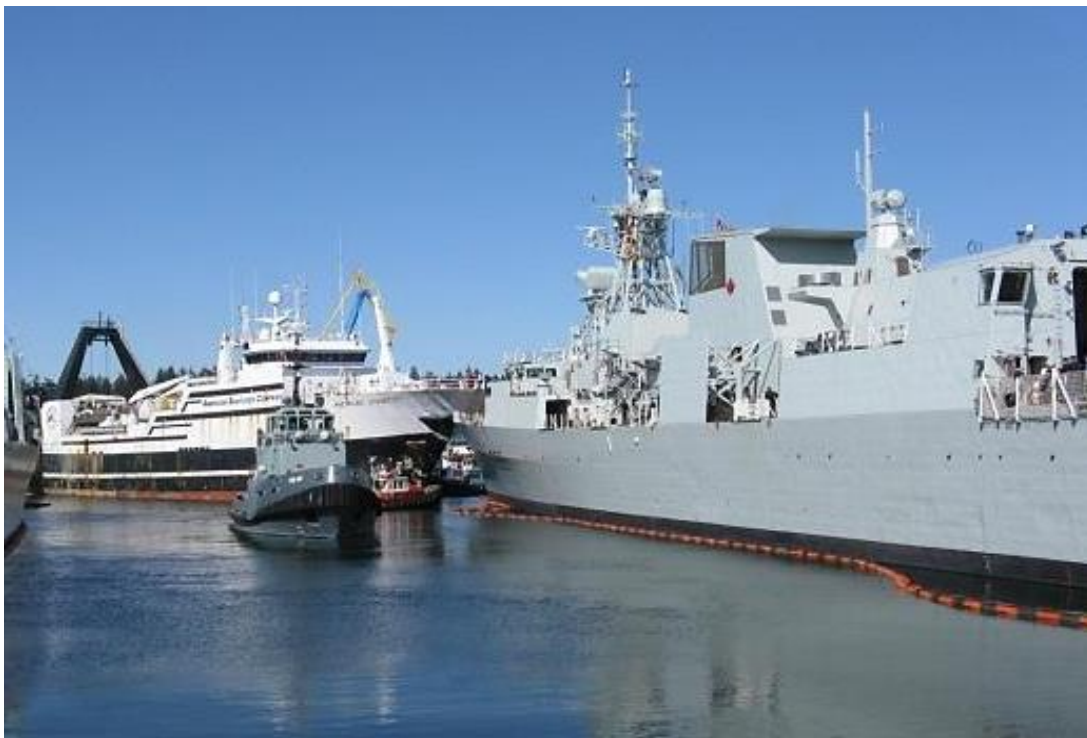
Fishing vessel *American Dynasty* (white vessel at left) and Canadian Naval frigate *Winnipeg* after the collision. (Photo by Transportation Safety Board [TSB] Canada)

At 0817, the bow of the *American Dynasty* struck the port side of the *Winnipeg*. The collision causing the frigate's stern to pull away from the dock, damaging the vessel's starboard side and Pier 3C. Six shipyard workers on board the *Winnipeg* sustained minor injuries in the collision.

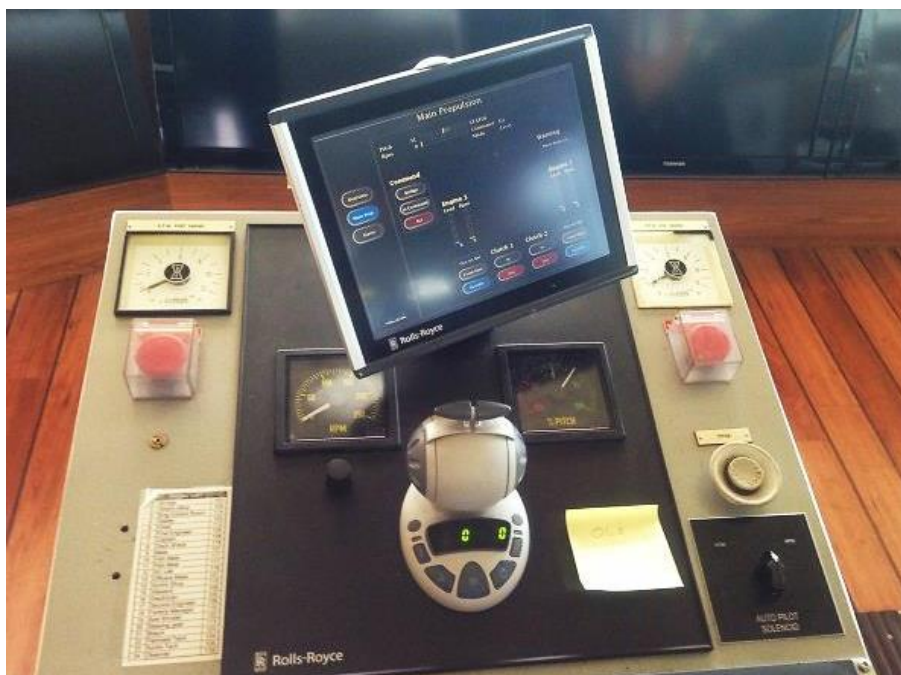
The chief engineer was unaware of the impending collision and continued his efforts to manually close the breaker connecting the auxiliary generator to the main switchboard to regain electrical power. He also tried to close the breakers for both shaft generators to energize the switchboard, but failed. Shortly thereafter, the auxiliary generator shut down. The chief engineer left the engine room and entered the machinery space to investigate why the auxiliary generator had stopped. About this time, the master ordered the anchor dropped and tried to sound the trawler's whistle, which had not been tested before leaving Seattle and which was nonfunctioning. Neither the master nor the pilots tried pressing the main engines' emergency stop buttons, which were located prominently on the bridge control console. Pressing these buttons would have stopped the propeller shaft from rotating and would have reduced the trawler's speed.

Section of the *American Dynasty*'s bridge control console with the red emergency stop buttons. (Photo by the NTSB)

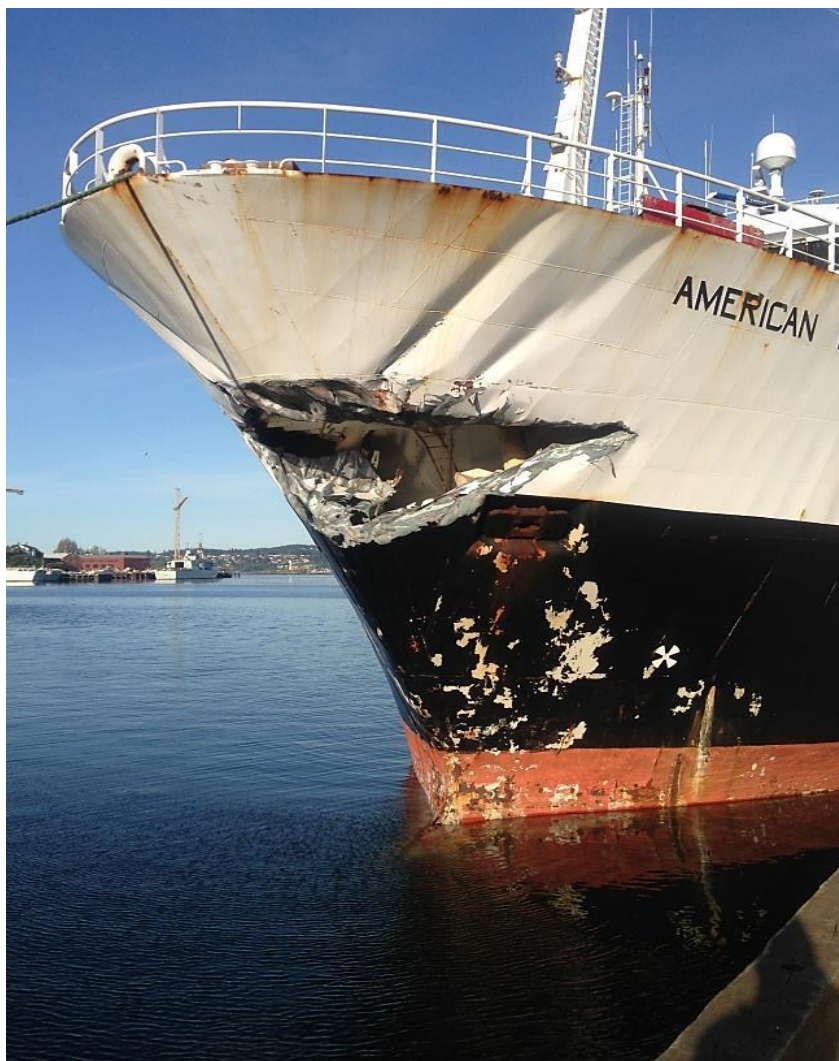
The *American Dynasty*'s bow shell plating, forepeak tank, chain locker, and deck plating were deformed as a result of the collision. The damage was estimated at \$450,000.

Damage to the bow of the *American Dynasty*. (Photo by the NTSB)

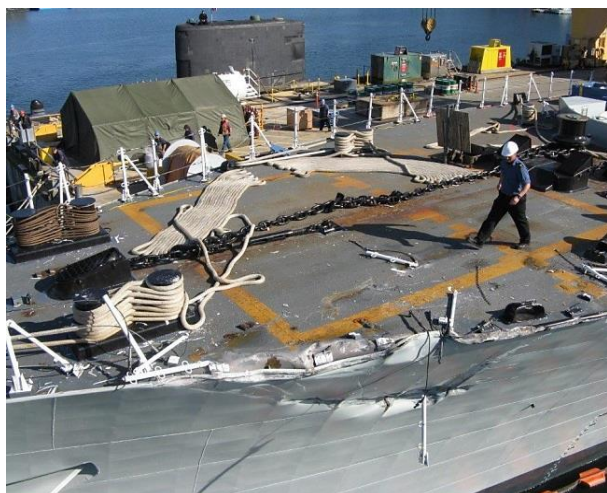
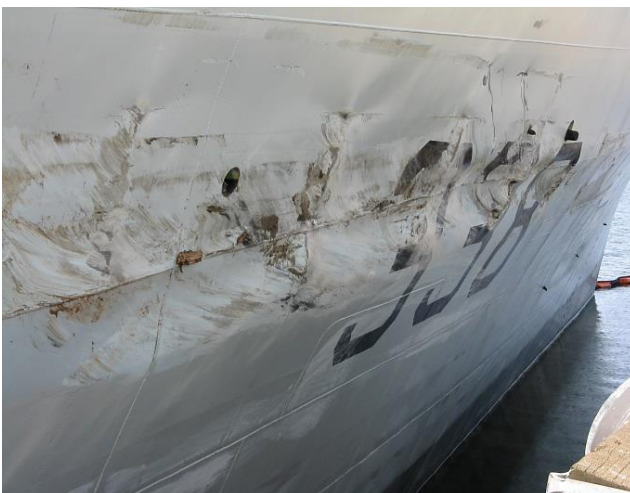
The *Winnipeg* sustained buckled deck plating and indentations in the shell plating on both port and starboard sides. A section of steel rebar penetrated the shell plating at frame 14. At the stern, the starboard side of the transom corner above the waterline made contact with the pier and was damaged. No damage estimate was released for the *Winnipeg*, but its damage was substantially greater than the *American Dynasty*'s.

Left, damage to the *Winnipeg's* port side; right, damage to the starboard side. (Photos by TSB Canada)

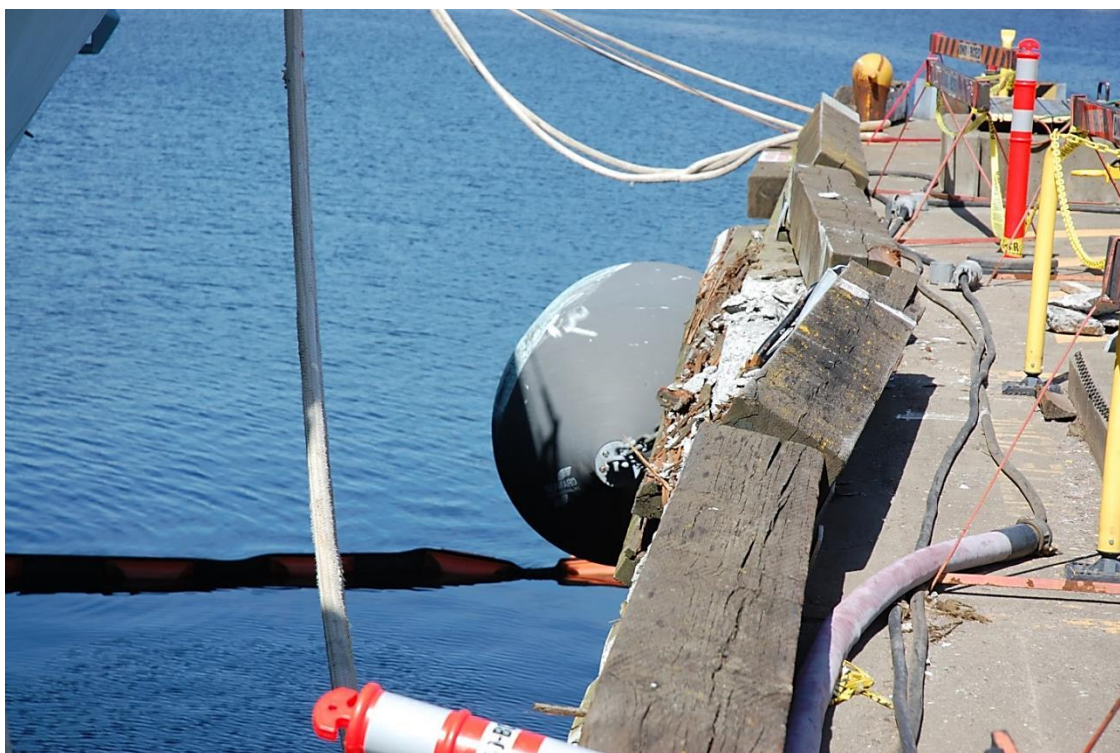
The concrete and wood fenders of Pier 3C were crushed when the *Winnipeg* made contact with it. Forty feet of concrete pier were crushed, and 100 feet of wooden beams were split and displaced. The cost of repairs to the pier was estimated to be \$75,000.

Damage to Pier 3C at the Canadian Forces Base in Esquimalt. (Photo by TSB Canada)

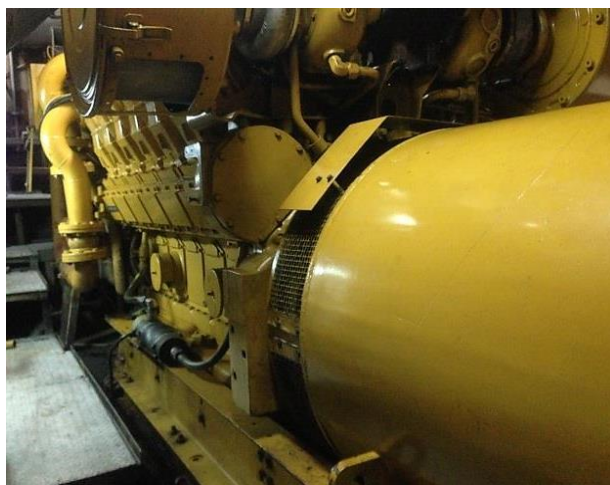
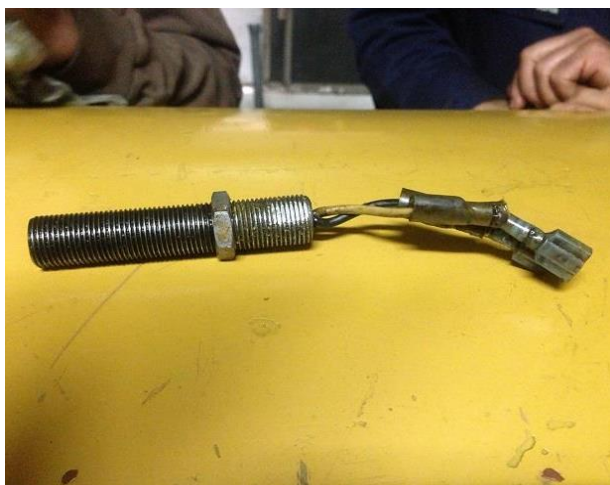
After the accident, investigators examined all of the equipment to determine the cause of the power loss. The decrease in electrical load that occurred when the master shut off equipment, such as the bow thruster motor, caused a change in the auxiliary generator's speed and frequency. This change, in turn, likely caused the generator breaker to trip open on the main switchboard. Ultimately, the auxiliary generator's diesel engine also shut down.

Investigators found a damaged magnetic pickup sensor on the auxiliary generator's diesel engine. This sensor was supposed to emit a signal to the engine's speed control unit, allowing controllers to regulate the engine's speed; if the sensor failed, the engine was designed to shut down. However, investigators discovered that a failsafe feature on the auxiliary generator's control panel had been disabled with a bypass jumper wire, and this prevented the engine from shutting down when the sensor failed. It could not be determined when or why the failsafe had been disabled, nor why the auxiliary generator's engine eventually shut down despite the bypass.

***American Dynasty's* auxiliary generator (left); the generator's damaged magnetic pickup sensor (right). (Photos by the NTSB)**
